Maryland Historical Trust Determination of Eligibility Form

Property Name: CCC Cottages (DNR-3 & 4) Inventory Number: PG:85B-7
 Address: Holly Trail in Cedarville NRMA Historic District: Yes ☒ No
 City: Cedarville Zip Code: County: Prince Georges
 USGS Quadrangle(s):
 Property Owner: Maryland Department of Natural Resources Tax Account ID Number:
 Tax Map Parcel Number(s): Tax Map Number:
 Project: demolition of old office building Agency: DNR
 Agency Prepared By: Maryland Historical Trust
 Preparer's Name: Jonathan Sager Date Prepared: 03/26/2008
 Documentation is Presented In: PG:85B-7 and CH-769
 Preparer's Eligibility Recommendation: Eligibility Recommended ☒ Eligibility Not Recommended
 Criteria: A B C D Considerations: A B C D E F G
Complete if the property is a contributing or non-contributing resource to a NR district/property:
 Name of the District/Property:
 Inventory Number: Eligible: Yes Listed: Yes
 Site Visit by MHT Staff: Yes No Name: Date:

ADDENDUM TO ORIGINAL FORM - CCC COTTAGES

INVENTORY FORM FOR STATE HISTORIC SITES SURVEY

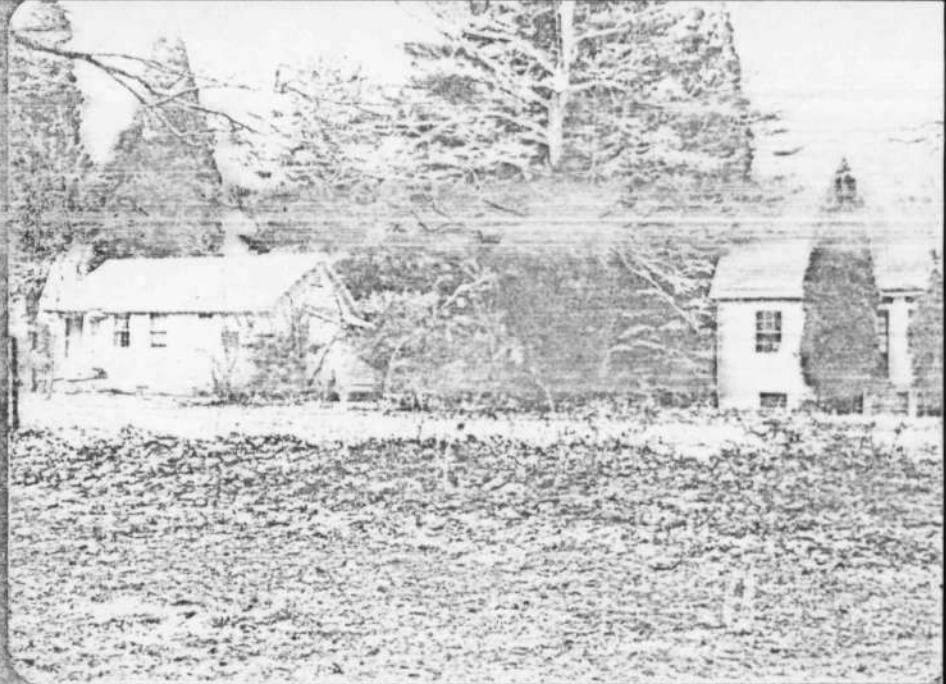
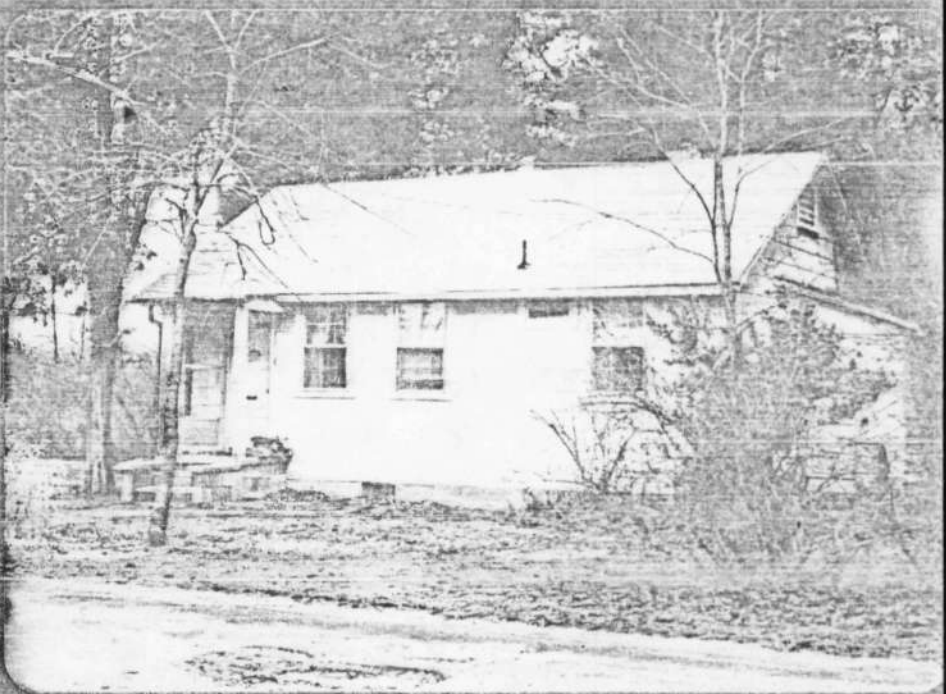
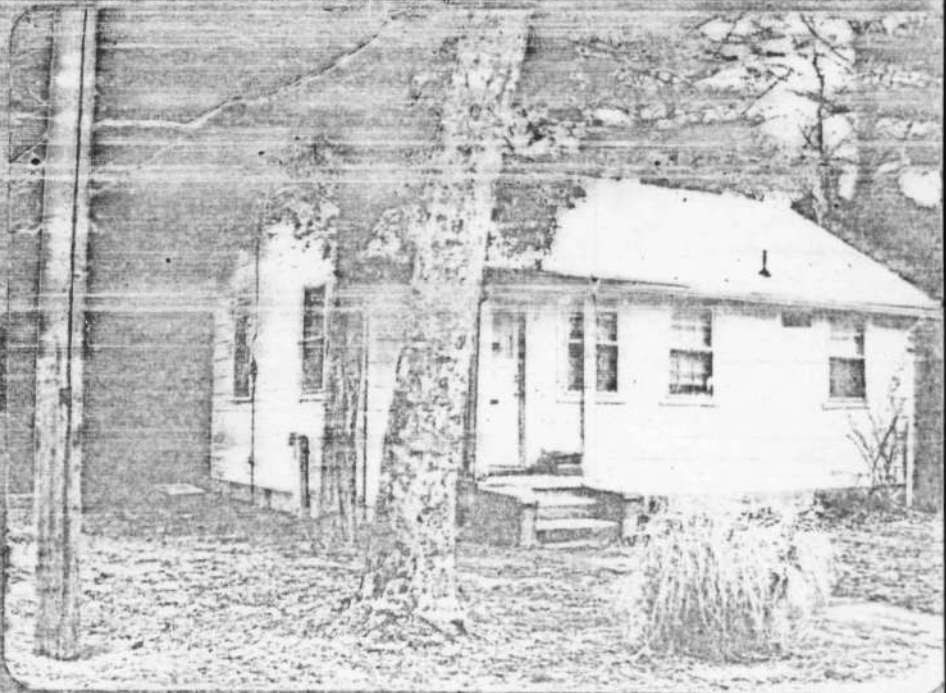
PG-85-B-6
 85-B-7
 85-B-8
 CCL Cottages
 top - site of 2 cottages
 Westernmost cottage - center south & east facades
 bottom - south & west facades

The westernmost CCC Cottage is similar in most details to its counterpart. The differences lie in the main facade arrangement.

The westernmost cottage has an entrance in the westernmost bay of the main facade and six-over-six windows in the other three bays. This entrance has a smaller porch constructed of concrete block with a small shed roof. There is also a small two-pane ventilator window on the west of the easternmost six-over-six sash window. The kitchen wing on this structure is at the east gable end but is set back further than the one on the easternmost structure.

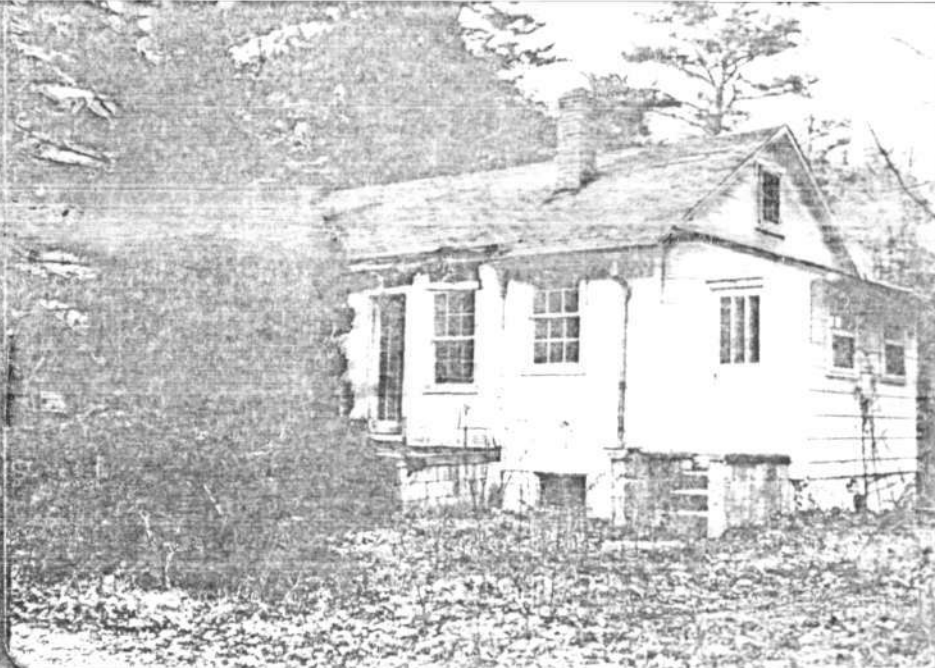
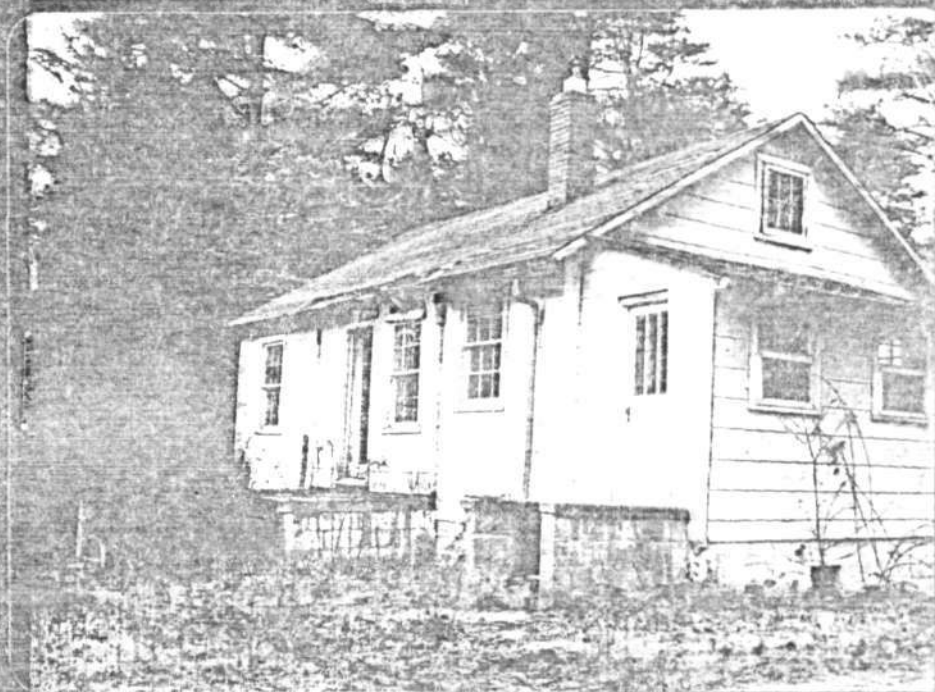
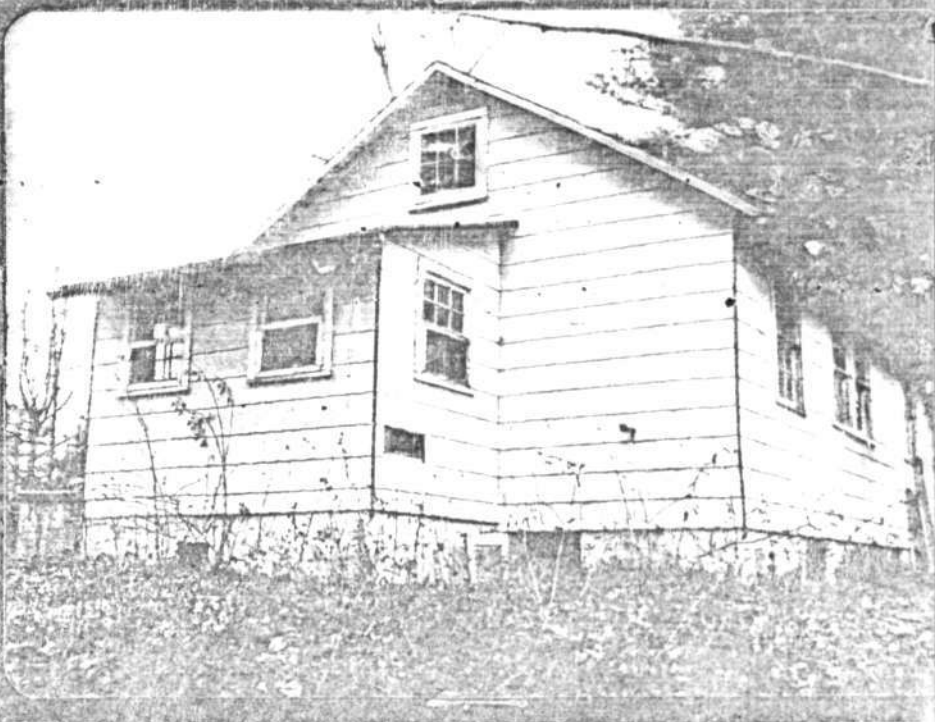
CLL Cottage - Easternmost Cottage

The eastern most CCC Cottage has a main facade that faces south. There are four bays across the main facade with the entrance located in the second bay from the west side of the structure. The other bays contain six-over-six sash windows. A modern concrete block entrance porch led up to the entrance. The east gable end contains the kitchen wing which has a shed roof. The south facade of the kitchen wing contains an entrance with a concrete block stair entrance. On the east facade of the wing are two six-over-three sash windows. The east facade of the main section contains a recessed entrance down to the basement with poured concrete stairs leading down. There is also a six-pane window in the gable. The rear facade has three bays with six-over-six windows in the outer bays and a double six-over-six window in the center bay. The west gable end has two six-over-six windows and a six-pane window in the gable. The foundation is elevated about two and ^{one}/₄ half feet above ground level allowing for three-pane foundation windows located on each facade. The roof has exposed rafter ends and is covered in asphalt shingles. A tall chimney flue is located on the south side of the ridge of the roof. The flue is constructed of brick, has a brick corbelled cap, with a ceramic tile liner projecting out of the top.

top - south & east facade

center - " "

bottom - east & north facade

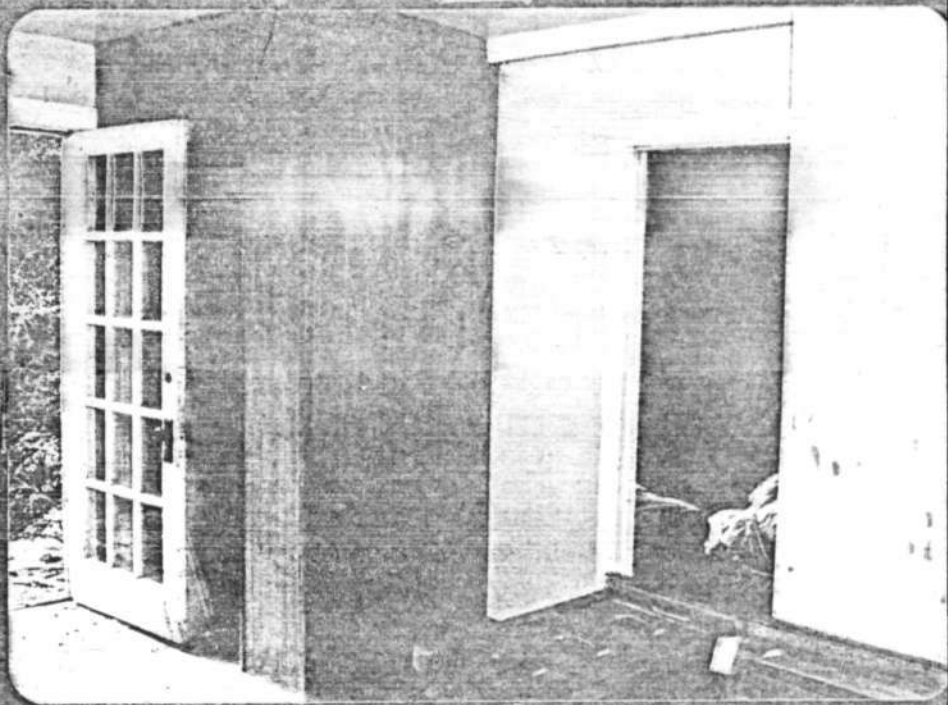
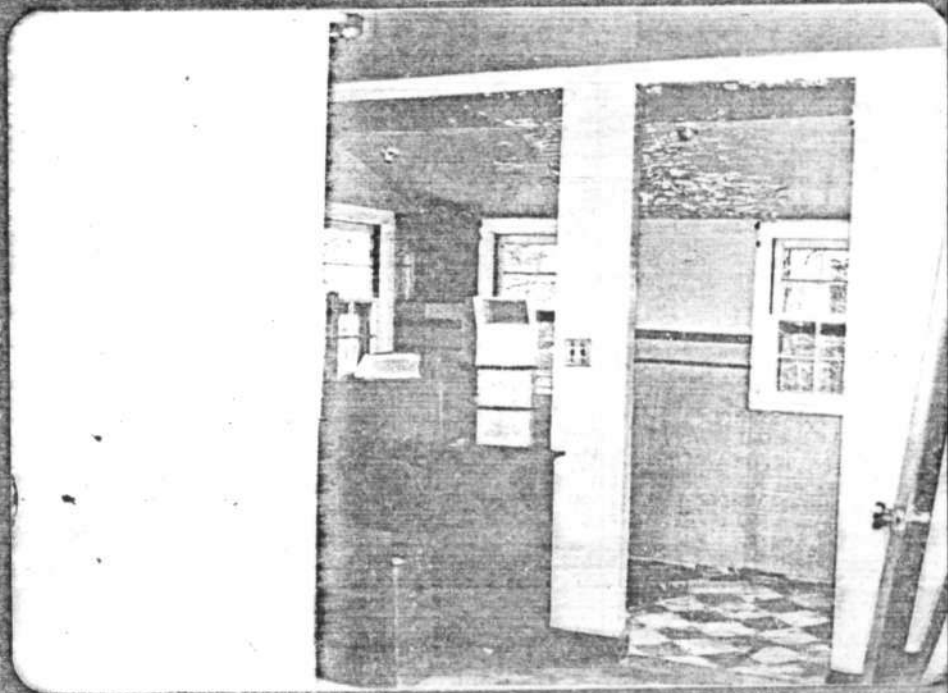
PG-85-B-6/85-B-7/85-B-8
CCC Cottage - Interiors Eastman Cottage

The interior of both cottages appears to be repartitioned from its original condition. This ^{is} particularly evident with ^{new} partitioned ^s created to frame in bathrooms to the structures. It is difficult to determine where the original partitions existed, but it appears that originally each cottage had two rooms. The front entrance would lead in to a large room and a smaller room would be partitioned at one end of the building. At the east end of the structure existed the shed kitchen which was open into the main section with a small counter creating the division into the cottage.

top - rear towards entrance & west room
bottom - entrance towards kitchen

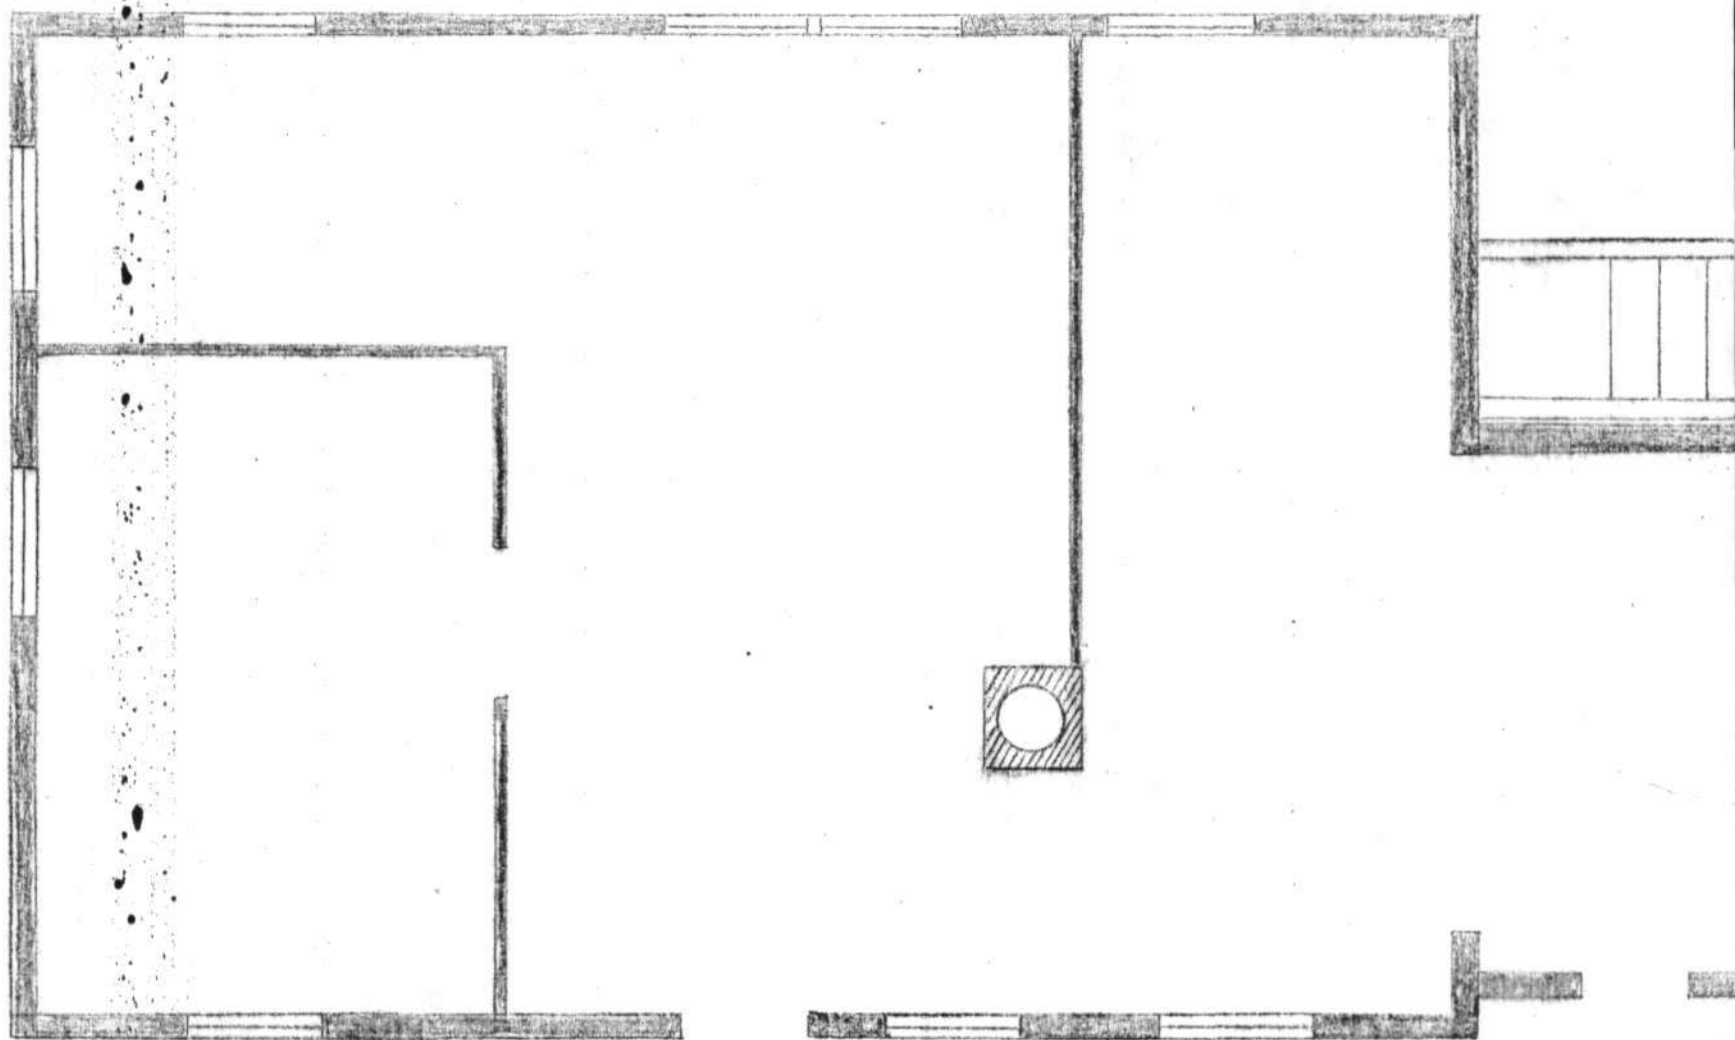
CCC Cottage

scale $\frac{1}{4}" = 1 \text{ foot}$

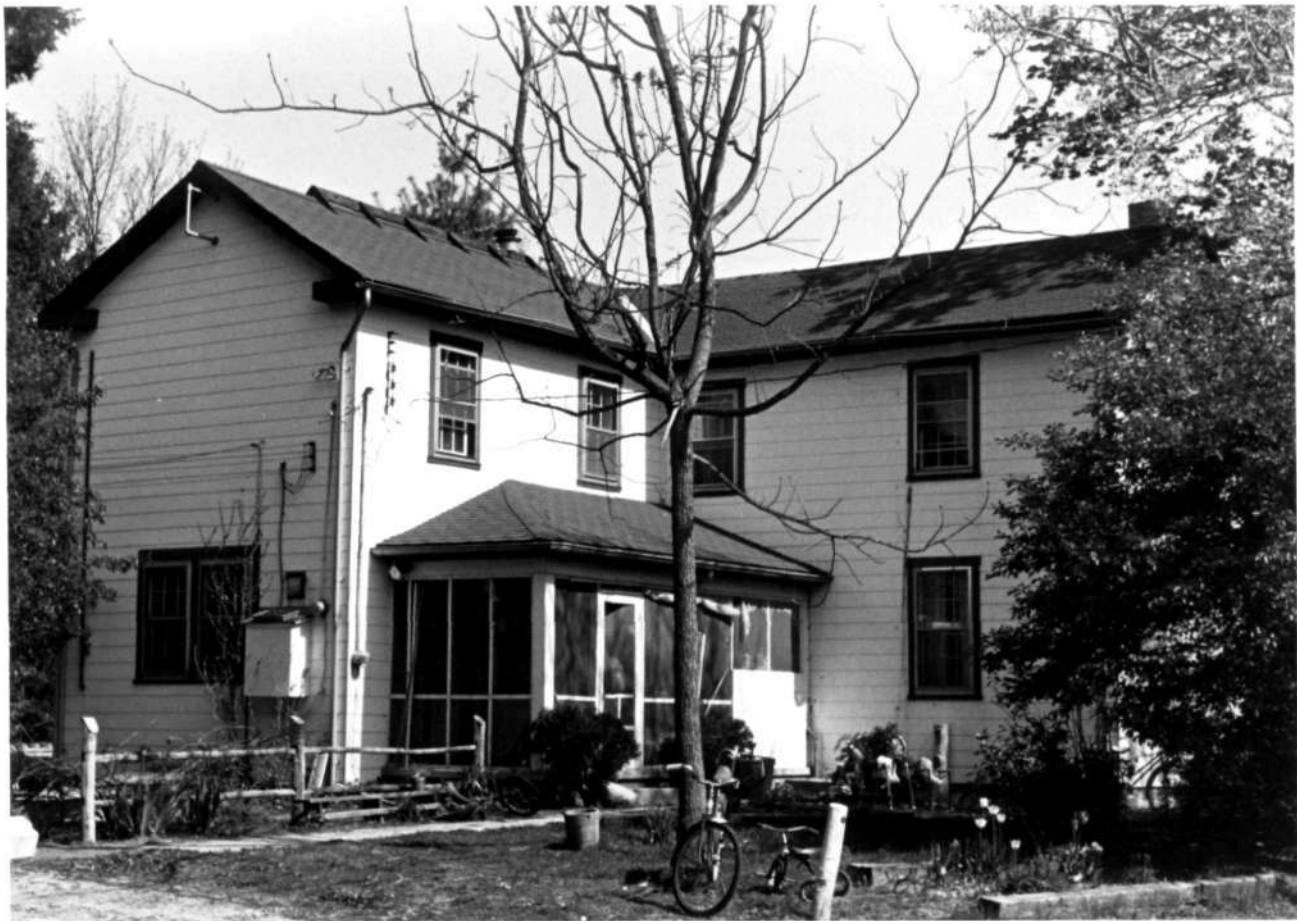
PG: 85B-6

Cedarville Farmhouse - DNR-1, dating from the late 19th century, is located within Cedarville Natural Resources Management Area on the side of Cedarville State Forest Road, north of Butler Branch. This two-story, gable roofed, asbestos over frame farmhouse is three bays wide and one bay deep with a two-story addition of equal height extending from the rear facade. The main (north) facade is defined on the first story by a central doorway flanked by 6/6 sashed windows. A half-hipped, roofed, screened porch projects from the main entrance. The three corresponding openings of the second story are marked by 6/6 sashed windows. All windows of both stories have plain wooden surrounds. An internal brick chimney is located in the eastern gable end.

CEDARVILLE NRMA FARMHOUSE
CEDARVILLE, MARYLAND
CEDARVILLE NRMA

SE ELVATION

The Cedarville farmhouse is in good condition and deserves to remain an active DNR rental property. The small CCC cottage which functions as park offices is also in good condition. Although its use as administrative office space is a bit cramped for park personnel, the building should in some way continue to serve the park needs with regard to the adjacent structure: if because of its poor condition it cannot be rehabilitated for park use, regrettably this report concedes its ultimate demolition.

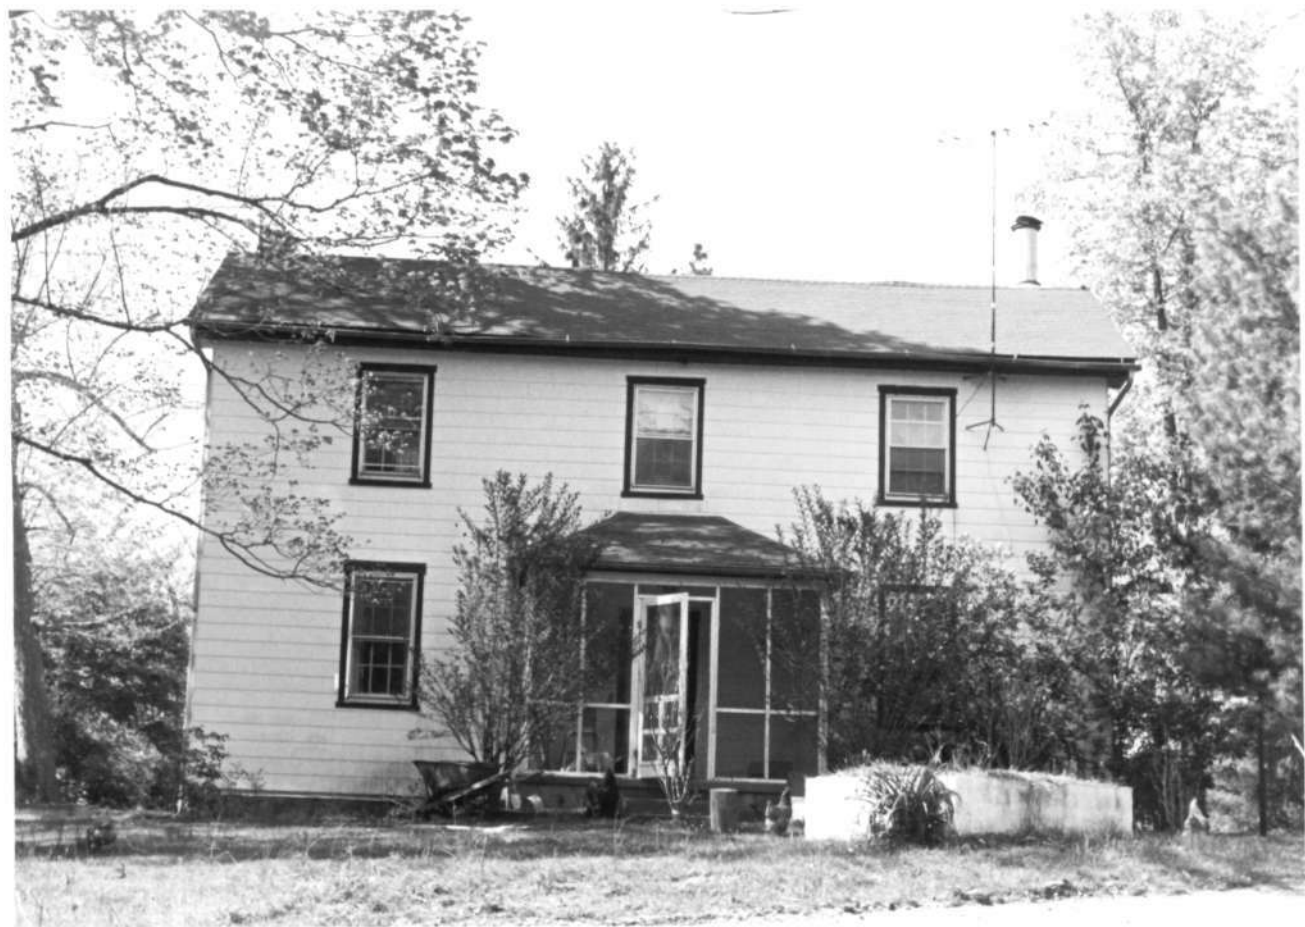
P6: 85B-6

The rear (south) facade repeats the window features of the main facade. Windows with identical timber surrounds are found at the first and second story levels of the easternmost bay and at the second story level of the central bay. Windows vary in sash--6/6 like the main elevation or 2/2 sash indicating a later replacement. Two windows of 6/6 sash also appear in the second story of the ell located in the westernmost bay of the rear facade. A half-hipped, roofed, screened porch runs across the entire length of this first story. A bricked-in stove flue is externally located on the west facade of the ell.

CEDARVILLE NRMA FARMHOUSE
CEDARVILLE, MARYLAND
CEDARVILLE NRMA

NORTH ELEVATION

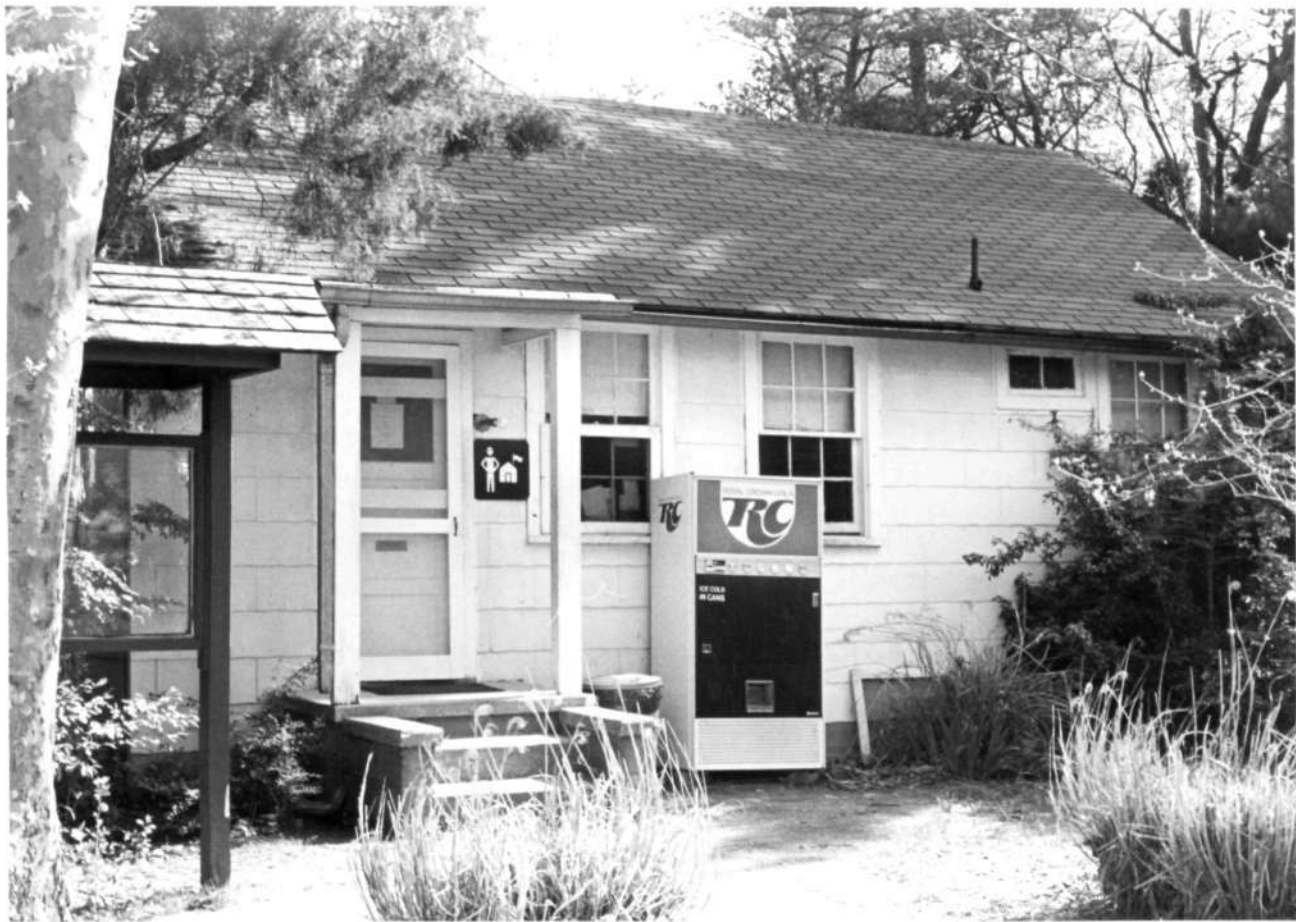
PG. 85B-7
CEDARVILLE CCC COTTAGE
CEDARVILLE, MARYLAND
CEDARVILLE NRMA

CCC Cottages - DNR 3, 4. Immediately to the east of the farmhouse on the east side of Cedarville State Forest Road are two CCC constructed frame cottages which each measure roughly 25 feet by 15 feet. These one story, gable roofed structures have their main entrance on the south facade. Windows are 6/6 sash with plain wooden surrounds.

The westernmost cottage currently functions as the Cedarville NRMA office and therefore is in serviceable condition. The second cottage is vacant and in poor condition.

S ELEVATION

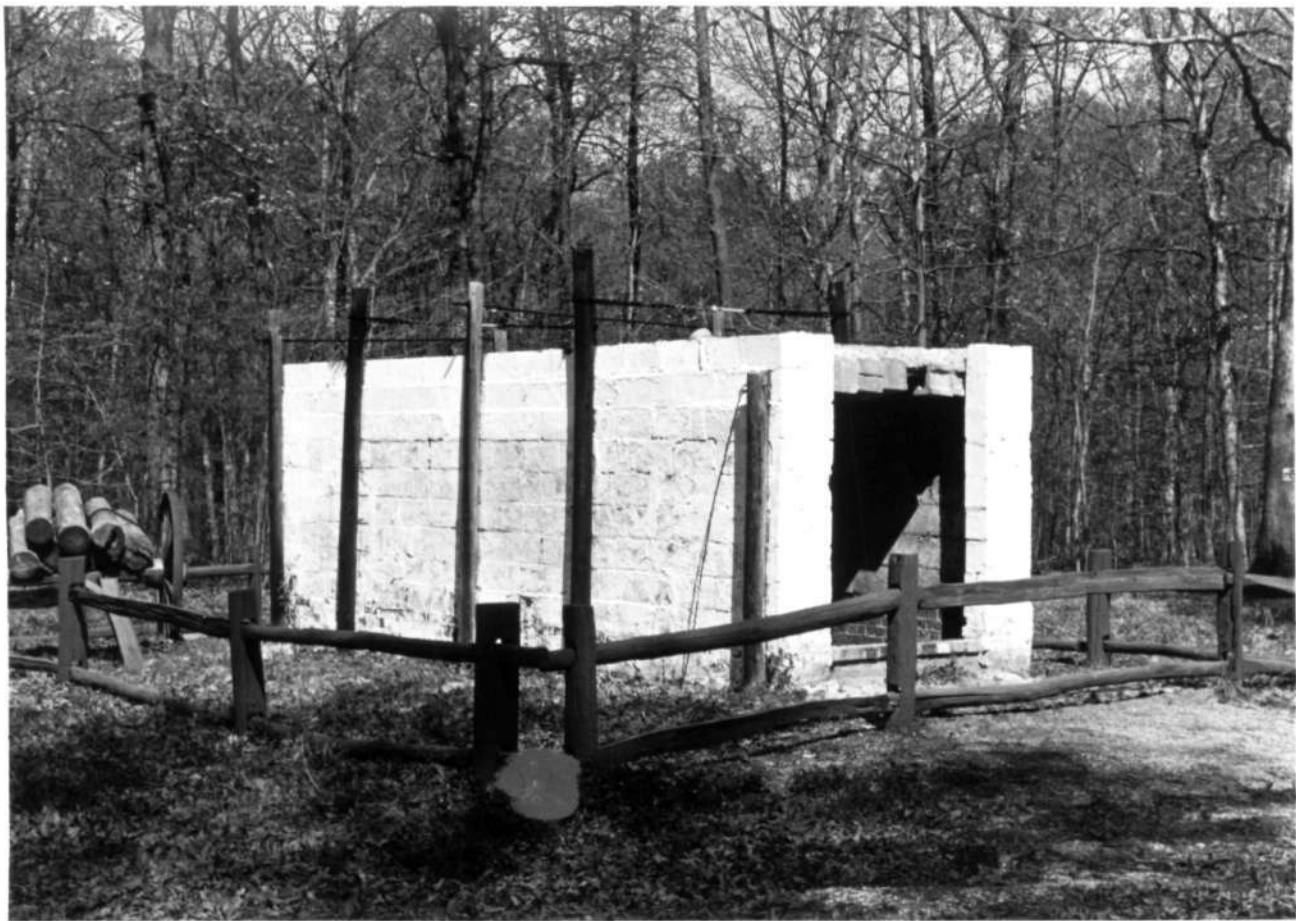
PG: 85B-8

Charcoal Kiln - DNR-19. A charcoal kiln constructed in the late 1940s/early 1950s to demonstrate the production of charcoal in a masonry block is located south of the farmhouse on the west side of Cedarville State Forest Road. An identical kiln once operated adjacent to it. The following description of the kiln and its operation was authorized in May 1975 by Frederick R. Schutt, a Cedarville NRMA park technician.

This kiln, located in Cedarville Natural Resources Management Area, holds 4 cords of wood. It is built from cinder blocks. The approximate dimensions of the kiln are 18' long, 5'6" wide, and 7' high. The floor of the kiln is about 1½' below the

CEDARVILLE CHARCOAL KILN
CEDARVILLE, MARYLAND
CEDARVILLE NRMA
